Arizona Archaeological Society Prehistoric Sites -- Pueblo Grande

CONTRIBUTOR: Jim Britton - AAS Phoenix Chapter

PRESERVATION ISSUES AT PUEBLO GRANDE:

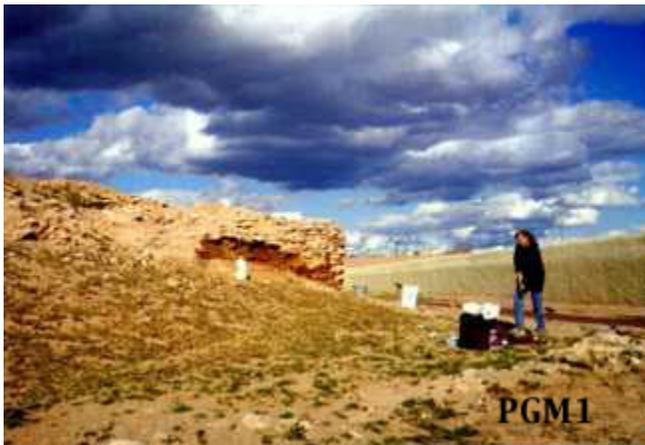
The south mound wall next to the SE corner demonstrates the type of basal erosion problem we have to contend with at Pueblo Grande. I will discuss the procedure used to stabilize this area. PGM1 shows the SE corner of the platform mound. The dark colored area (dark due to being wet from sprayer) is the eroded basal courses. The slope going up from where Chris is standing to the base of the wall is the backfill put in place by the National Park Service (NPS 1989-1991). You can see the backfill slope increases to the west (your left). The area to the west of this photo has backfill all the way to the top of the mound. You can see a close-up of this eroded area in Photo PGM2. This is a good example of basal erosion. It is caused by [rising damp](#) where moisture is drawn by capillary action up into the dry wall. As the moisture evaporates from the exposed basal courses the mortar breaks down and falls to the ground in the form of powdery soil. If the soil contains salt, the salt crystallizes and adds to the erosion process.

The erosion extended 3.2 meters to the west of the SE corner. It extended as far as 30cm into

the mound. The first step in stabilizing the area was to remove all soft mortar and loose or decomposing stone. Since the erosion went so deep into the mound, we needed to establish a base or foundation to set replacement stones on to fill the void. The next step is to mix the mud. We used a combination of two soils to get a color that closely matched the original color. To this we add crushed granite gravel to serve as a temper and a marker.

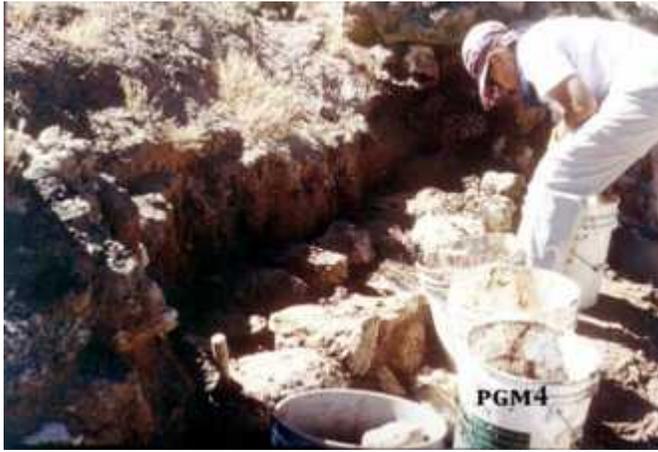
1995 During this year the volunteer group concentrated on the west mound wall. The main project was to reconstruct a wall section referred to in the documentation notes as "The Gap". This gap was 2.4m long and began 33.7m north of the SW mound corner. This sloping area contained backfill which included a drain pipe from a drop box above. Since it was backfill we were able to excavate to establish a relatively solid base upon which the foundation stones could be laid.

As you can see in Photo PGM4, we used very large indurated caliche stones laid two wide for the foundation. At times a large "tie stone" would be placed to span the entire width of the wall, thus tying the two stones and forming a good solid wall to withstand the dead load force created by the [differential fill](#). Above the foundation we used smaller stones that were more matched to the stone size on either side of the gap. Since a drop box was already in place above this area, once the wall reconstruction was complete we contoured the area behind the wall to direct the water runoff toward the drop box. This would prevent the water from flowing over the wall face and eroding the mortar. Due to the success in the "Gap" reconstruction, we were ask to do another mound wall section located between 78.5 and 80.5m north of the SW corner. This is near the NW mound corner. Runoff from the mound top flowed down the sloping side and made a large erosion cut which resulted in no visible wall above the NPS backfill. This can be seen in Photo PGM5.

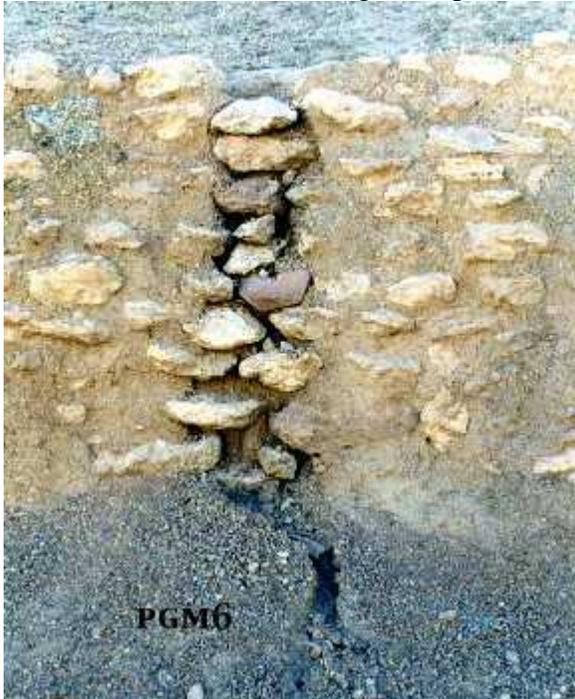
1998 The runoff from the sloping mound sides would flow over the 20m length of reconstructed and stabilized wall face. After each rain, there would be small erosion cuts along the entire length of wall. It was a maintenance headache. It was decided to focus the runoff to five points along this wall section. A diversion berm was constructed using small (1 to 2 fist size) stones, one stone wide, along the top of the wall face.

An opening approximately 50cm wide was left at 5 points where any runoff would tend to flow. The berm would direct the runoff to the drain opening. This isolated the erosion to only the five drain opening, thus cutting repointing time dramatically. This is illustrated in Photo PGM6. During the first nine month of this year the wall face below the five runoff openings were repointed 3 times. In September we reduced the openings from 5 to 3. This further reduced maintenance time after each rain. A major stabilization of the north mound wall was started and completed this year. This wall section was located between the NE mound corner and the backfill buttress. The concave area of this wall was stabilized by reinforcing the basal courses with additional stone and mud. The concave area was filled to make the wall straighter and more

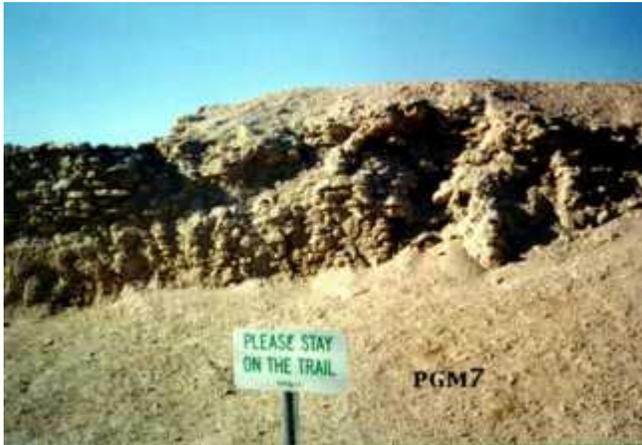
1999 The main project for this year was the stabilization of the south mound wall by reconstructing a wall face 4.35m in length beginning 12.0m east of the SW mound corner. The condition before work on this wall can be seen in Photo PGM7. To the right of this photo is the NPS backfill buttress that extends to the top of the mound.

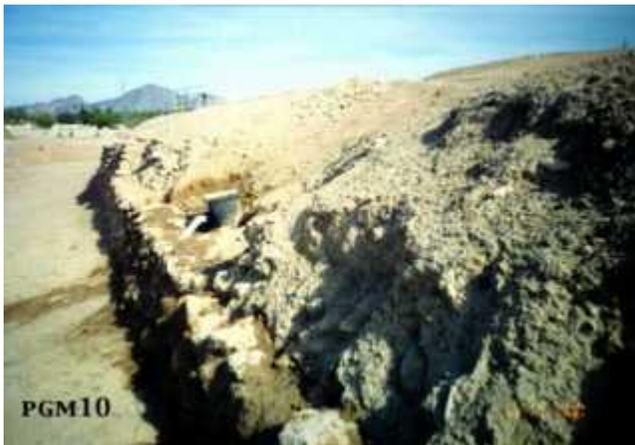
During the first five months of year 2000, work has concentrated on the west wall of the mound. The wall section between 46.0m and 57.0m north of the southwest mound corner has eroded to form a dished shaped slope from the mound top to the top of the NPS backfill slope (See photos). Discussion between Bostwick (Phx. City Archaeologist) and Britton resulted in a decision to reconstruct this wall section.

The erosion in this area is due to water runoff from the sloping side of the mound, not from the mound top. Rain hitting the top of the mound in this area flows into a drop-box and down a PVC pipe to current ground level. It was decided to install a drop-box just behind the

proposed reconstructed wall face. Since erosion had removed the original outer mound wall in this area, there would be no adverse impact to any original mound [matrix](#) to install the drop-box and pipe. The drain pipe from the new drop-box was connected using a "T" to the existing pipe which drains the mound top.

After the new drain pipe was attached we began laying a footing using large [indurated caliche](#) stones. Where possible the wall face was made two stones wide. To avoid impacting original mound matrix we, at times, were only able to lay one stone wide. As the wall increased in height each workday, we would backfill behind it. We backfilled each workday to assure that if it rained before our next workday, water would not be trapped behind the new wall. The wall height is determined by the location of the drop-box. Photo PGM10 shows the wall being reconstructed with the drop box in place. You can see in this photo the dished-out area on the mound slope that will flow into this drop box. The wall must to be slightly higher than the top of the drop-box. As you can see in this photo, wall needs several more layers of stone to build it up to the height required by the box location. The backfill behind the wall will be contoured so that runoff would flow toward the box and away from the wall face. There should be no runoff over the wall face. The only damage to this wall face will be from direct rain hitting it.

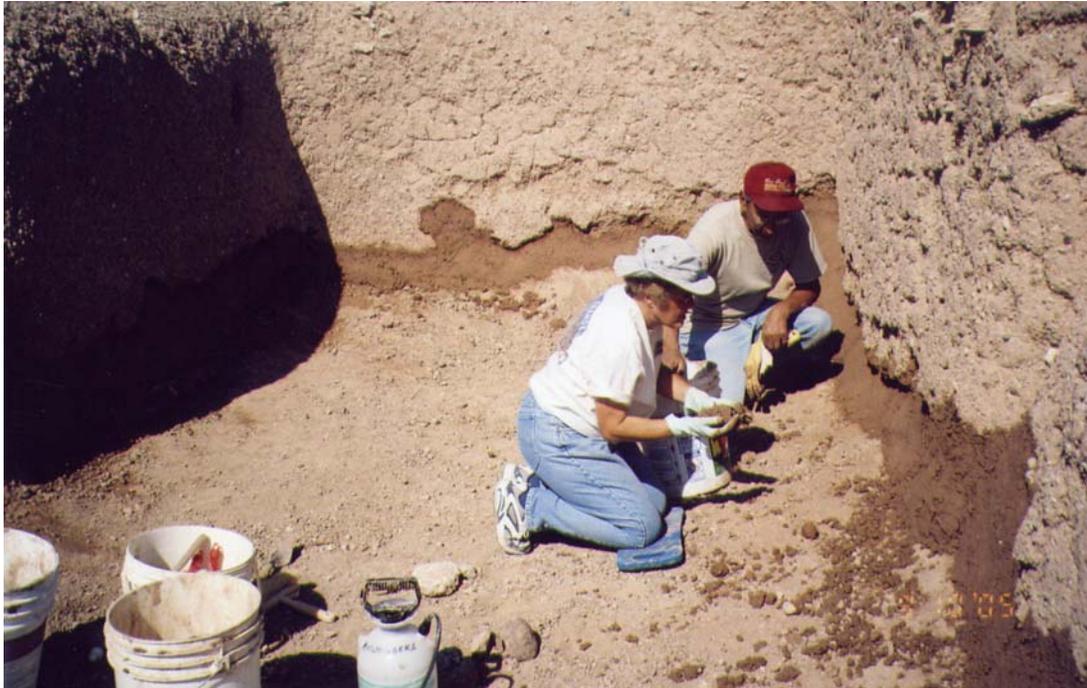
All four perimeter walls of the platform mound needed some spot repairs due to basal erosion and eroded mortar joints. After a heavy rain or wet period, the moisture in the ground is pulled up into the dry walls by capillary action. The bottom or basal areas of the walls become moist causing a mechanical breakdown of the clay molecules. As the wall dries a void is formed as dirt particles fall from the wall. If not repaired the wall could eventually collapse. We completed recapping Room JH11 that had been started last year. We then recapped and slurry coated Room JH10 located on top of the mound across the walking trail from Room 11.

Walt Lesko & Donna Beng repairing local erosion with Soil Shield-Ls amended mud.
