Arizona Archaeological Society Prehistoric Sites -- Pueblo Grande

CONTRIBUTOR: Jim Britton - AAS Phoenix Chapter

PRESERVATION ISSUES AT PUEBLO GRANDE:

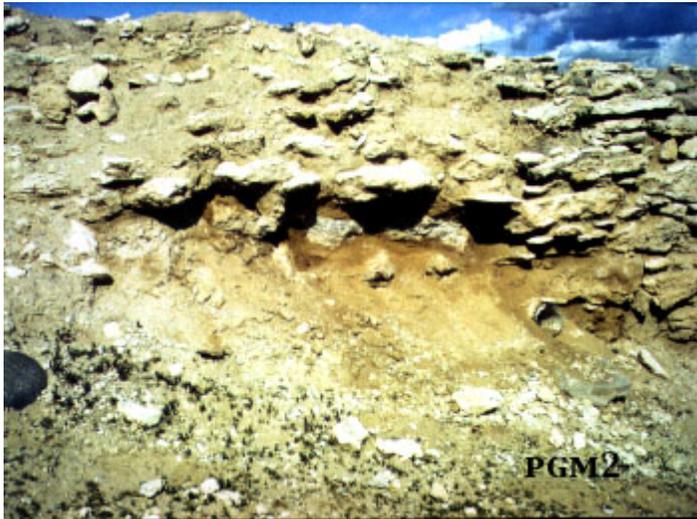
The erosion extended 3.2 meters to the west of the SE corner. It extended as far as 30cm into

the mound. The first step in stabilizing the area was to remove all soft mortar and loose or decomposing stone. Since the erosion went so deep into the mound, we needed to establish a base or foundation to set replacement stones on to fill the void. The next step is to mix the mud. We used a combination of two soils to get a color that closely matched the original color. To this we add crushed granite gravel to serve as a temper and a marker.

Before applying the mud, it is necessary to wet the original surface and any new stones. This wetting allows the new mud to adhere to the original surface and slows the drying process. Stones to be laid should be selected based on size that agrees with the original stones used. At Pueblo Grande we usually leave the stone face exposed so that the visitors can see that the wall was constructed of uncoursed stone (indurated caliche). The result of our stabilization work is shown in Photo PGM3 which was taken one month later.
