Prehistoric Sites -- Elden Pueblo

STABILIZATION HISTORY AT ELDEN:

RECENT STABILIZATION ACTIVITY AT ELDEN:

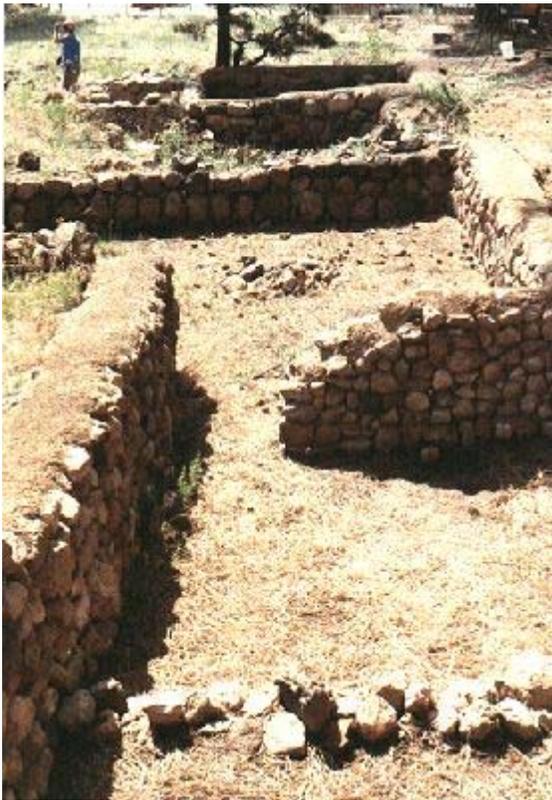
Stabilized and reconstructed rooms along the south end of the pueblo looking east.

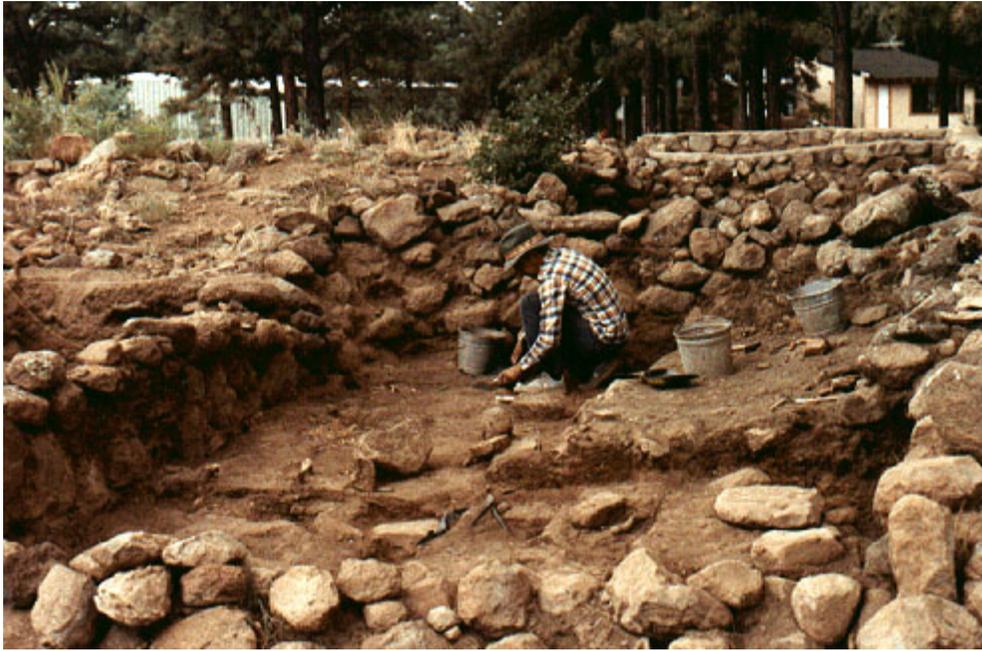
Room 9 being excavated in 1989. This room has now been stabilized and partially reconstructed.

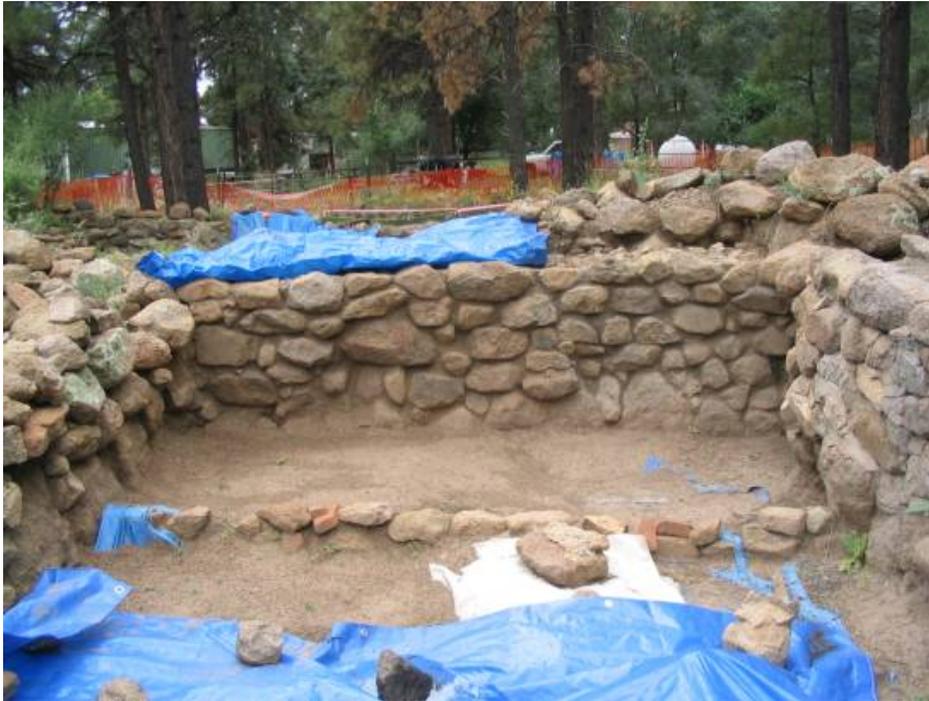
This is a photo of Room 1, south interior after stabilization has been completed this year. This work was an emergency project due to the collapse of the wall after re-excavation in 2002.

Another reason to stabilize this now was that the AAS Field School was excavating the other side of this wall and needed some stability for their project.

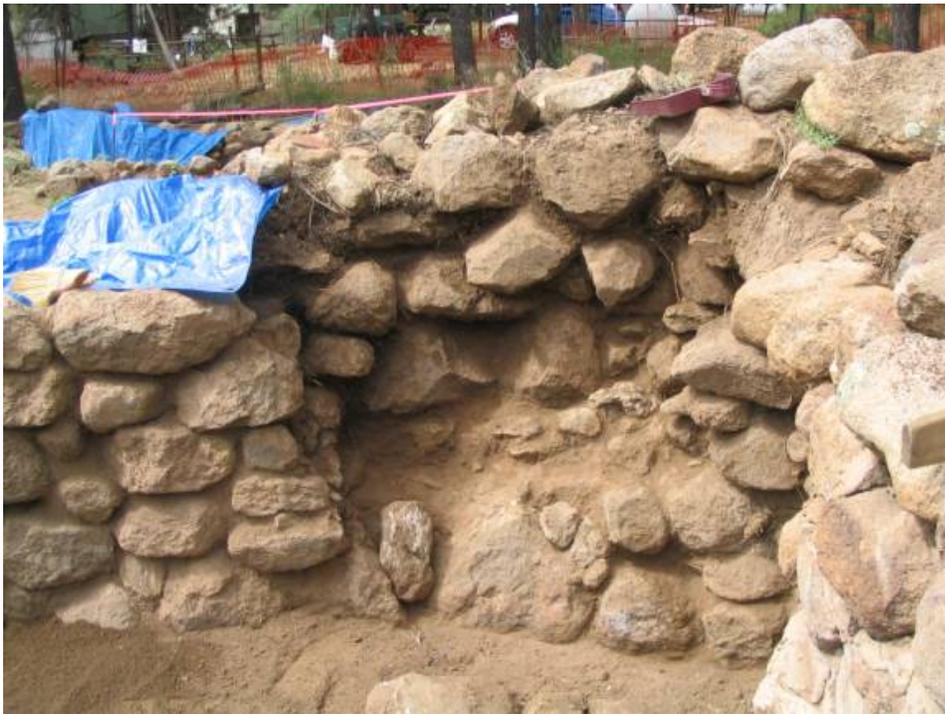
This is a picture half way through the Room 1 project.

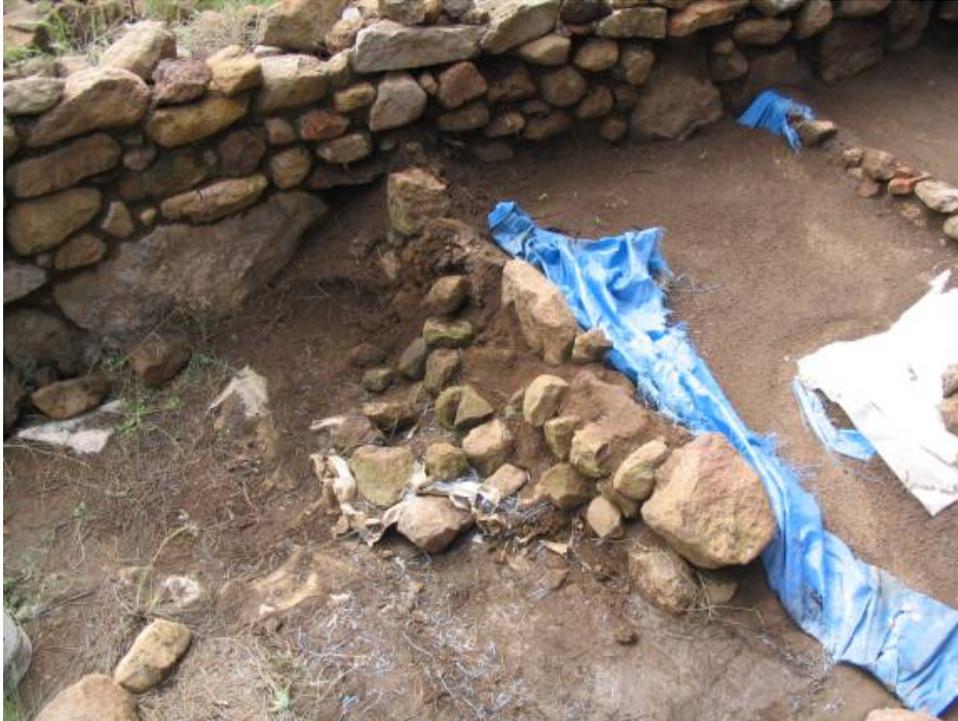
This is the north wall of room 1 and it needs serious stabilization. It appears to be a dividing wall, one course thick, maybe two courses in some spots. A simple job apparently. Then we realized we didn't know the floor relationship of room 1 to room 2, the room just to the north. While we were determining that, we discovered some under-wall features that might pre-date both rooms. Or not. This little project is now on hold until spring, 2006. We need to think about this some more.

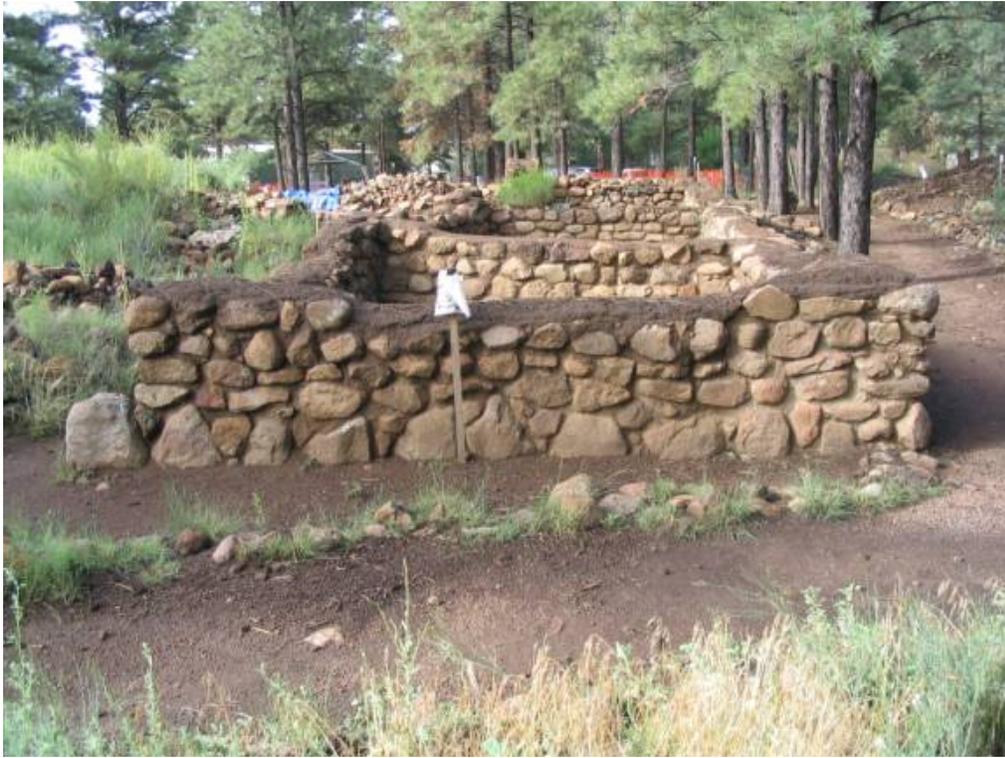
We didn't work here this year. I just think it's a nice picture. This part of the pueblo was stabilized and reconstructed in 1995-6 during the last Stab/Recon Field School.
